Walkability Audit

Davidstown Primary School

Davidstown,
Ballygillistown,
Enniscorthy
Co. Wexford

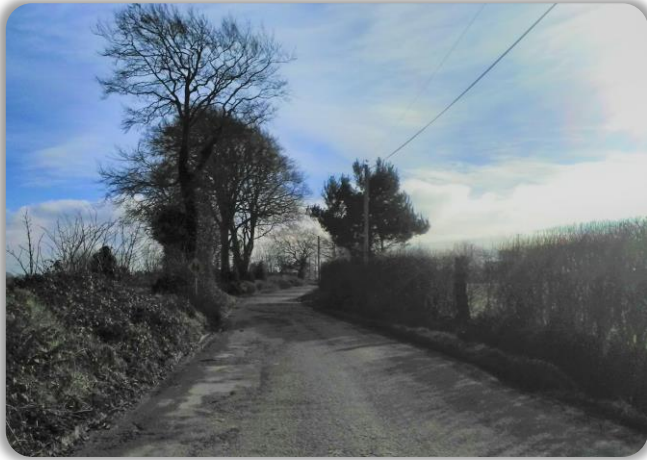
There is signage on the approach road to the school

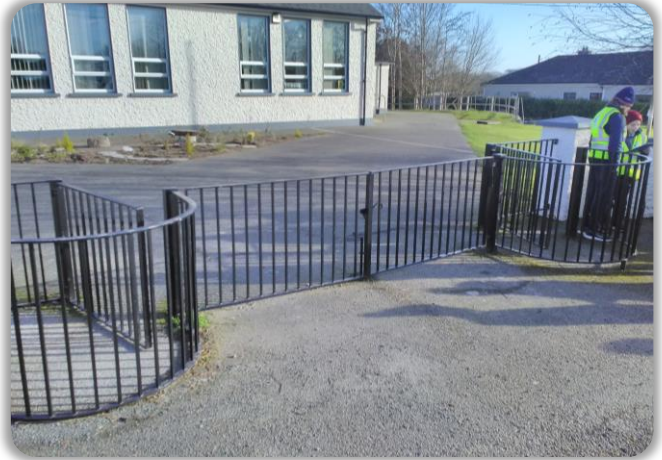
There is good safety gates outside the school

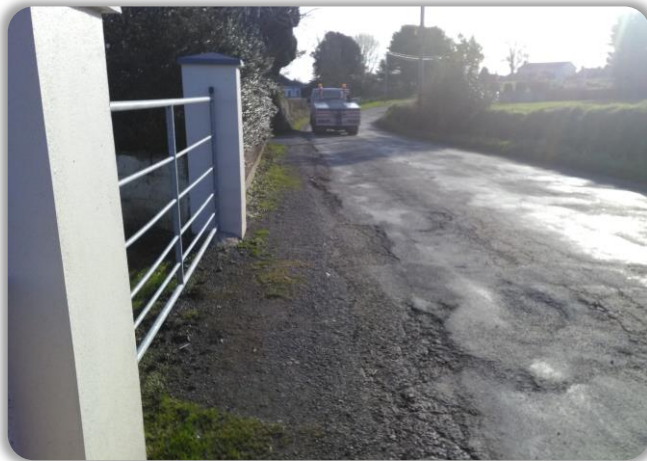
There is no footpath outside the school

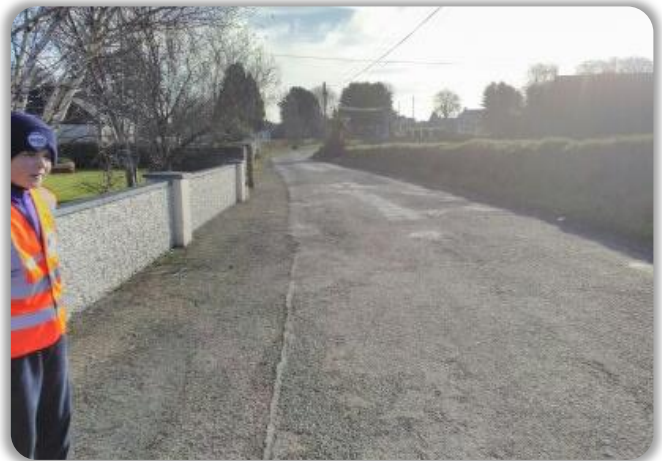
There is a dangerous bend on the route so walking is only safe on one side of the road

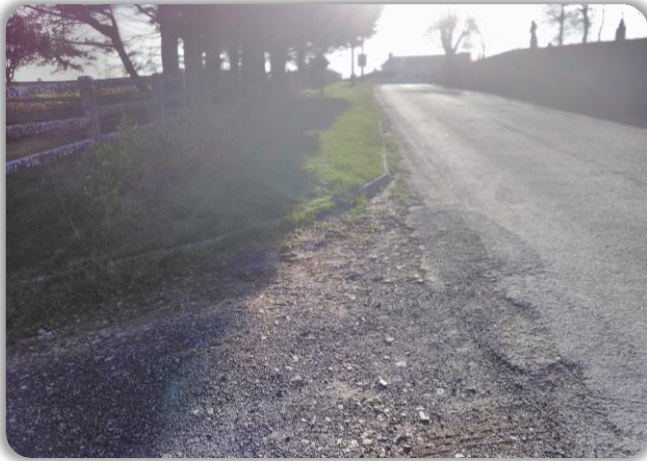
There is a wide grass verge on part of the route to the church

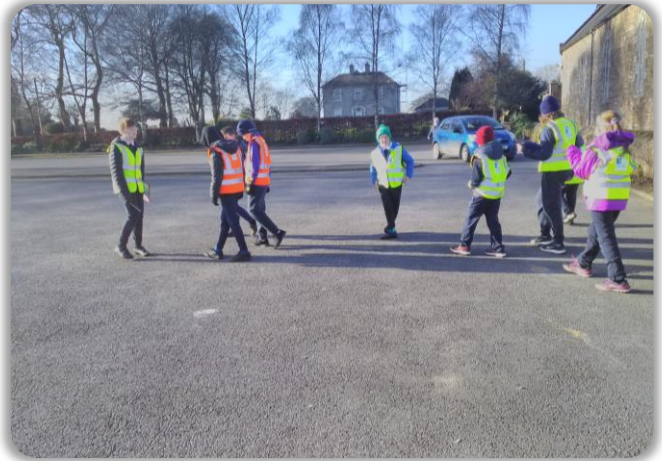
There is ample parking at the church

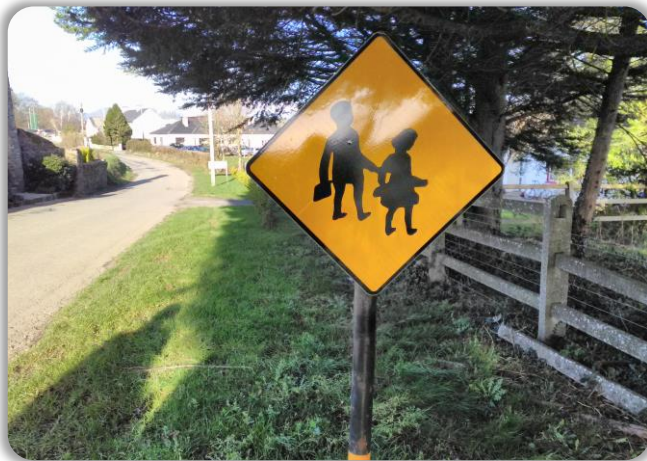
There was signage on approach to school from the church

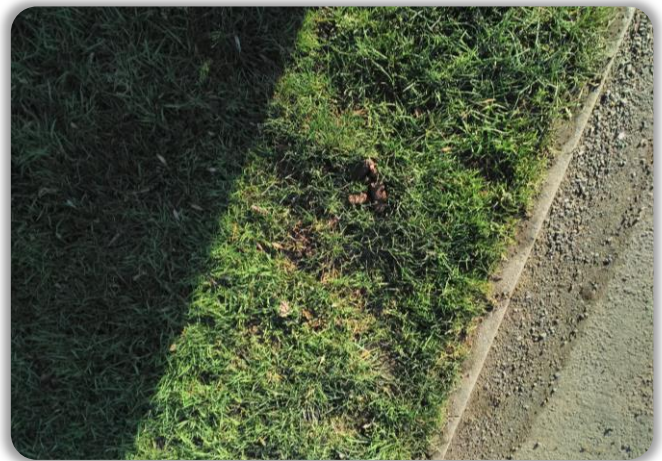
Dog fouling present on the grass verge

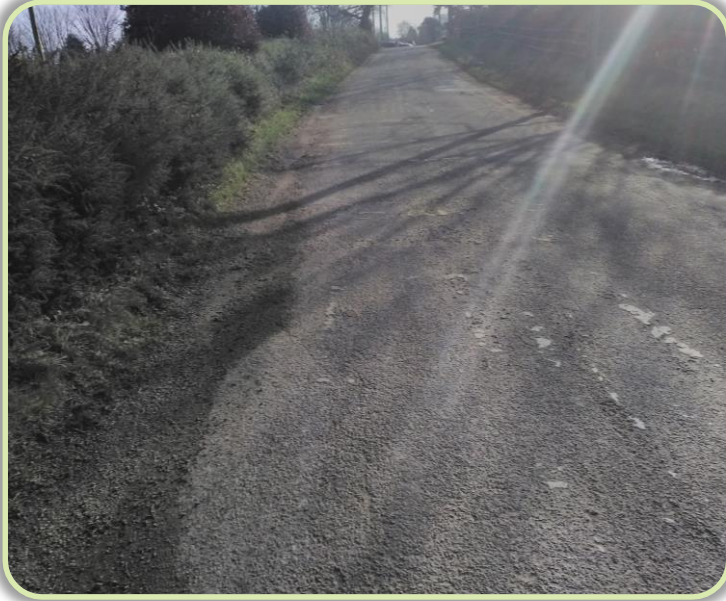
The road markings on the approach to the school have faded

New road markings to be painted

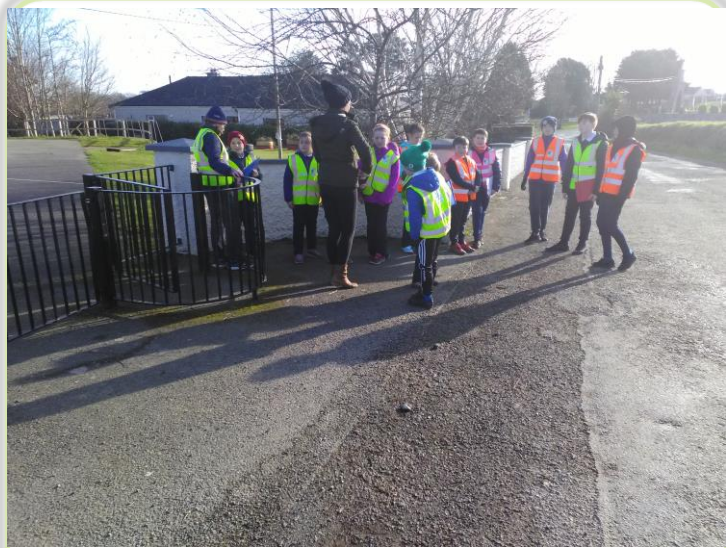
No keep clear road markings outside the school gate

Keep Clear Road markings to be painted outside school gate

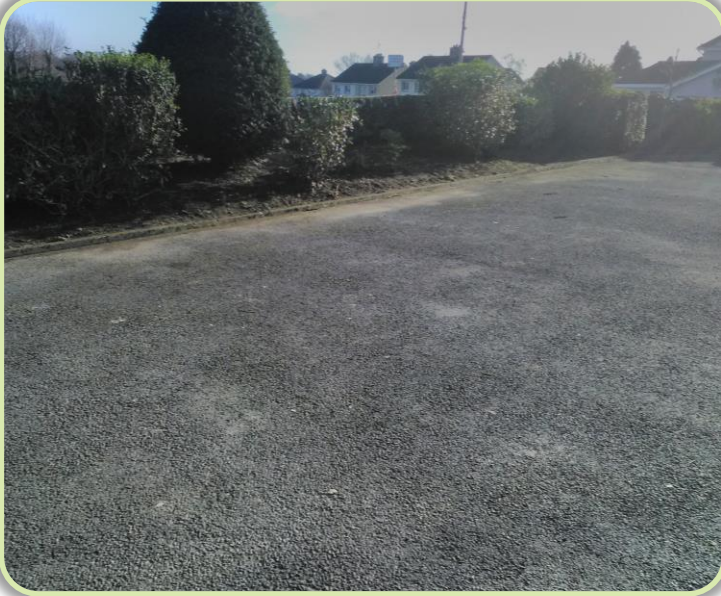
There were no parking spaces marked in the church car park

Parking spaces to be painted in church car park

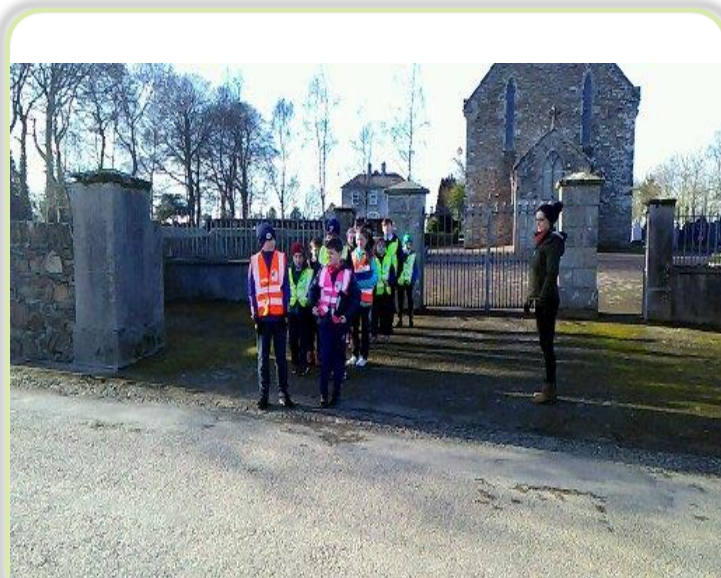
No pedestrian crossing outside church

Pedestrian crossing to be installed outside church

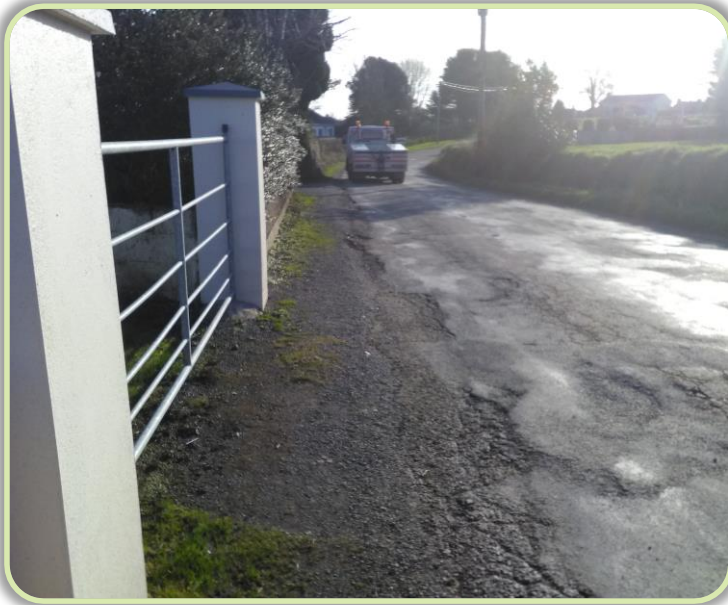
Traffic travelling very quickly outside the school

Speed limit of 30km to be installed outside school and speed readers and the addition of speed bumps or rumble strips
